**Flood Control Project Maintenance
Levee Inspections**

Maintenance Issue Types Only, Levee Inspection Report By Mile - Spring 2018

American River Flood Control District

Waterway	Bank	Unit Miles	Inspection Start/End	Inspector
Unit No. 01 Arcade Creek	Left	2.08	05/08/2018 05/08/2018	Sterling York

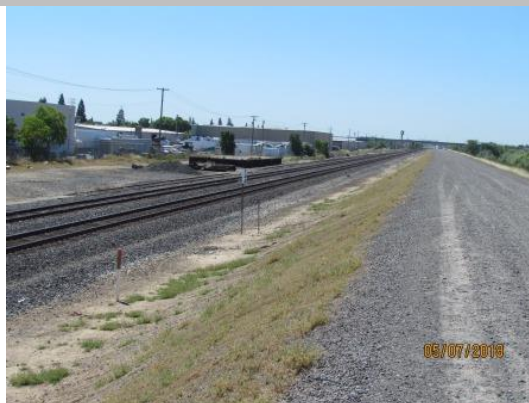
Photo 1 of 1 : SP_2018_NA0001_52_16_20180515_00041.jpg

LM Start	0.01	Rating **	A	Issue No.	16
LM End	3.90	Issue Type +	Ma	Location *	WS
Category	Earthen Levee			GPS Latitude/Longitude	
				Start	End
Item	Vegetation			38.603023 °	38.656907 °
				-121.472617 °	-121.474831 °
DWR ID	DWR_NA0001_02_s _ 2018_16				
Comment Code					
V1 : Control annual grass and weeds on the levee slopes and easements.					
Inspector Comment					
Annual vegetation is well maintained, Spring 2018.

View looking downstream landside of the well maintained annual vegetation.

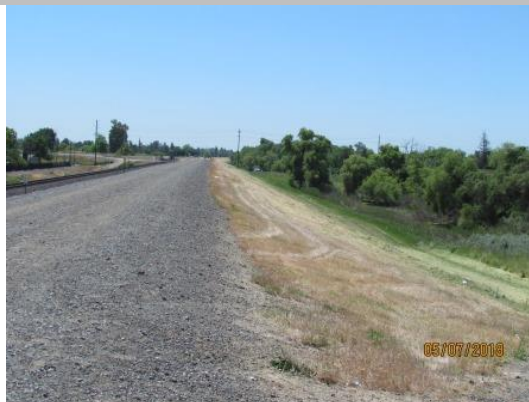
Photo 1 of 1 : SP_2018_NA0001_52_15_20180515_00043.jpg

LM Start	0.01	Rating **	A	Issue No.	15
LM End	3.90	Issue Type +	Ma	Location *	LS
Category	Earthen Levee			GPS Latitude/Longitude	
				Start	End
Item	Vegetation			38.603023 °	38.656907 °
				-121.472616 °	-121.474832 °
DWR ID	DWR_NA0001_02_s _ 2018_15				
Comment Code					
V1 : Control annual grass and weeds on the levee slopes and easements.					
Inspector Comment					
Annual vegetation is well maintained, Spring 2018.

View looking downstream waterside of the well maintained annual vegetation.

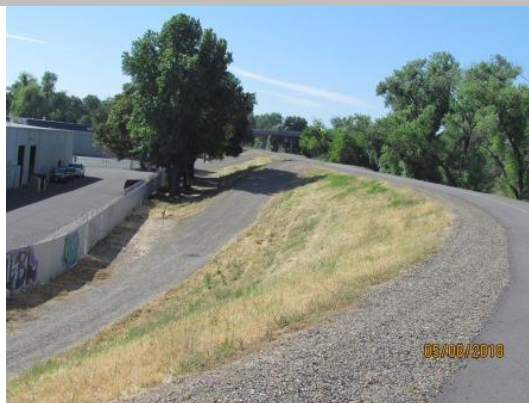
Photo 1 of 1 : SP_2018_NA0001_490_10_20180514_00031.jpg

LM Start	0.59	Rating **	A	Issue No.	10
LM End	3.47	Issue Type +	Ma	Location *	LS
Category	Earthen Levee			GPS Latitude/Longitude	
				Start	End
Item	Vegetation			38.589004 °	38.603037 °
				-121.428085 °	-121.472614 °
DWR ID	DWR_NA0001_03_s_2018_10				
Comment Code					
V1 : Control annual grass and weeds on the levee slopes and easements.					
Inspector Comment					
Annual vegetation is well-maintained. Spring 2018

View looking downstream landside of well-maintained annual vegetation. Spring 2018

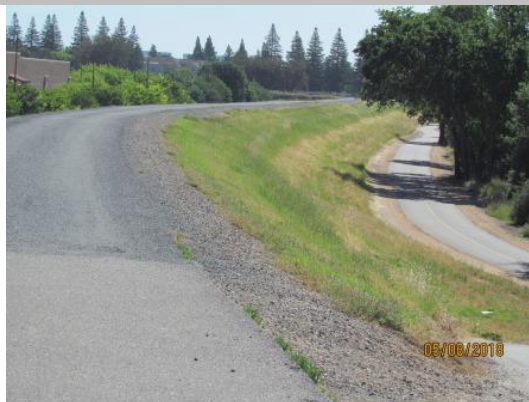
Photo 1 of 1 : SP_2018_NA0001_490_11_20180514_00034.jpg

LM Start	0.59	Rating **	A	Issue No.	11
LM End	3.47	Issue Type +	Ma	Location *	WS
Category	Earthen Levee			GPS Latitude/Longitude	
				Start	End
Item	Vegetation			38.589004 °	38.603037 °
				-121.428085 °	-121.472614 °
DWR ID	DWR_NA0001_03_s_2018_11				
Comment Code					
V1 : Control annual grass and weeds on the levee slopes and easements.					
Inspector Comment					
Annual vegetation is well-maintained. Spring 2018

View looking downstream waterside of well-maintained annual vegetation. Spring 2018

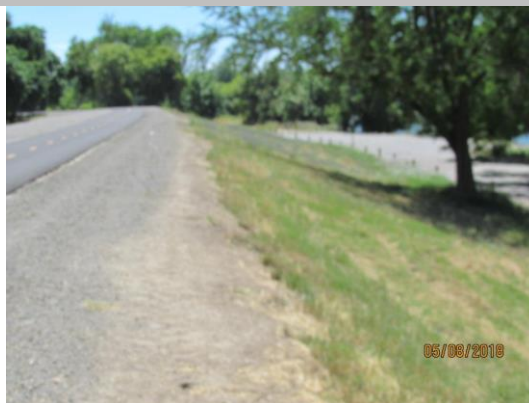
Photo 1 of 1 : SP_2018_NA0001_55_220_20180515_00263.jpg

LM Start	0.01	Rating **	A	Issue No.	220
LM End	1.86	Issue Type +	Ma	Location *	WS
Category	Earthen Levee			GPS Latitude/Longitude	
				Start	End
Item	Vegetation			38.596634 °	38.596116 °
				-121.506889 °	-121.477639 °
DWR ID	DWR_NA0001_04_s _ 2018_220				
Comment Code					
V1 : Control annual grass and weeds on the levee slopes and easements.					
Inspector Comment					
Annual vegetation is well maintained, Spring 2018.

View looking downstream waterside of the well maintained annual vegetation.

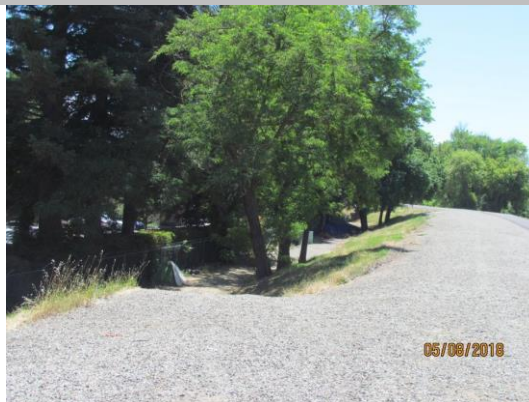
Photo 1 of 1 : SP_2018_NA0001_55_218_20180515_00264.jpg

LM Start	0.01	Rating **	A	Issue No.	218
LM End	1.86	Issue Type +	Ma	Location *	LS
Category	Earthen Levee			GPS Latitude/Longitude	
				Start	End
Item	Vegetation			38.596635 °	38.596116 °
				-121.506889 °	-121.477639 °
DWR ID	DWR_NA0001_04_s _ 2018_218				
Comment Code					
V1 : Control annual grass and weeds on the levee slopes and easements.					
Inspector Comment					
Annual vegetation is well maintained, Spring 2018.

View looking downstream landside of the well maintained annual vegetation.

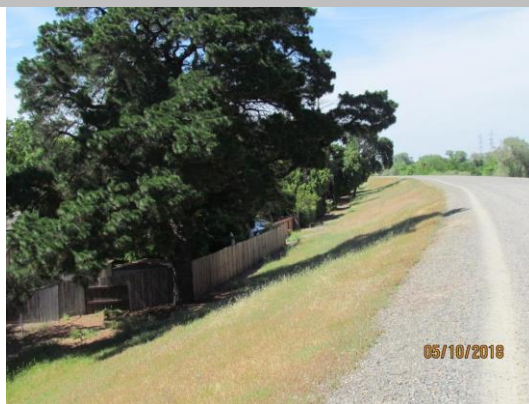
Photo 1 of 1 : SP_2018_NA0001_55_236_20180515_00266.jpg

LM Start	1.93	Rating **	A	Issue No.	236
LM End	10.83	Issue Type +	Ma	Location *	LS
Category	Earthen Levee			GPS Latitude/Longitude	
				Start	End
Item	Vegetation			38.595269 °	38.565566 °
				-121.477006 °	-121.351487 °
DWR ID	DWR_NA0001_04_s _ 2018_236				
Comment Code					
V1 : Control annual grass and weeds on the levee slopes and easements.					
Inspector Comment					
Annual vegetation is well maintained, Spring 2018.

View looking downstream landside of the well maintained annual vegetation.

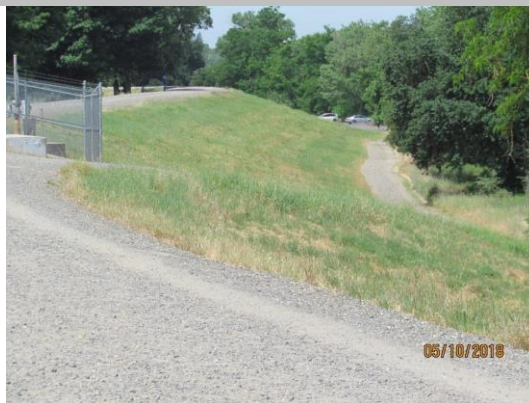
Photo 1 of 1 : SP_2018_NA0001_55_247_20180515_00268.jpg

LM Start	1.93	Rating **	A	Issue No.	247
LM End	10.83	Issue Type +	Ma	Location *	WS
Category	Earthen Levee			GPS Latitude/Longitude	
				Start	End
Item	Vegetation			38.595269 °	38.565567 °
				-121.477006 °	-121.351480 °
DWR ID	DWR_NA0001_04_s_2018_247				
Comment Code					
V1 : Control annual grass and weeds on the levee slopes and easements.					
Inspector Comment					
Annual vegetation is well maintained, Spring 2018.

View looking downstream waterside of the well maintained annual vegetation.

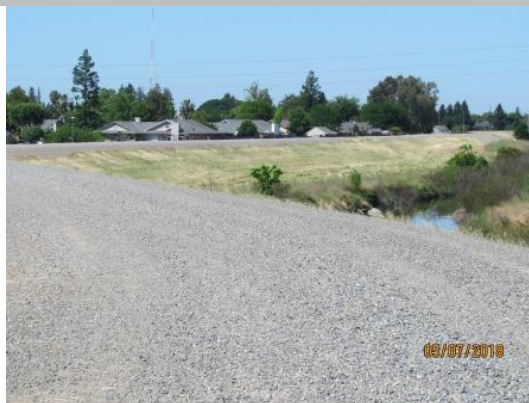
Photo 1 of 1 : SP_2018_NA0001_57_4_20180514_00008.jpg

LM Start	0.03	Rating **	A	Issue No.	4
LM End	1.29	Issue Type +	Ma	Location *	WS
Category	Earthen Levee			GPS Latitude/Longitude	
				Start	End
Item	Vegetation			38.657317 °	38.665210 °
				-121.474263 °	-121.452395 °
DWR ID	DWR_NA0001_06_s_2018_4				
Comment Code					
V1 : Control annual grass and weeds on the levee slopes and easements.					
Inspector Comment					
Annual vegetation is well-maintained. Spring 2018

View looking downstream waterside of the well-maintained annual vegetation. Spring 2018

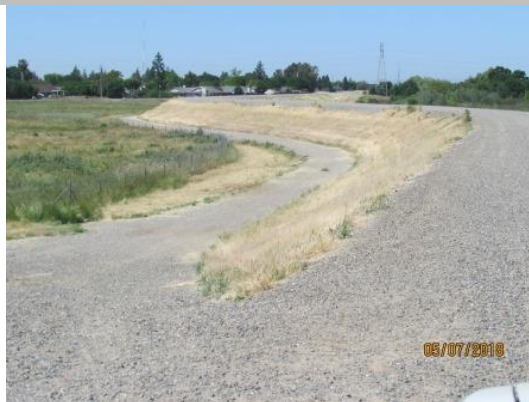
Photo 1 of 1 : SP_2018_NA0001_57_3_20180514_00007.jpg

LM Start	0.03	Rating **	A	Issue No.	3
LM End	1.29	Issue Type +	Ma	Location *	LS
Category	Earthen Levee			GPS Latitude/Longitude	
				Start	End
Item	Vegetation			38.657317 °	38.665210 °
				-121.474262 °	-121.452395 °
DWR ID	DWR_NA0001_06_s_2018_3				
Comment Code					
V1 : Control annual grass and weeds on the levee slopes and easements.					
Inspector Comment					
Annual vegetation is well-maintained. Spring 2018

View looking downstream landside of the well-maintained annual vegetation. Spring 2018

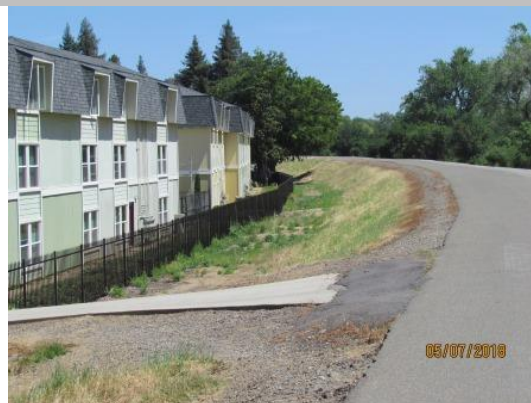
Photo 1 of 1 : SP_2018_NA0001_60_18_20180515_00045.jpg

LM Start	0.03	Rating **	A	Issue No.	18
LM End	4.19	Issue Type +	Ma	Location *	LS
Category	Earthen Levee			GPS Latitude/Longitude	
				Start	End
Item	Vegetation			38.567977 °	38.588967 °
				-121.383752 °	-121.428258 °
DWR ID	DWR_NA0001_09_s_2018_18				
Comment Code					
V1 : Control annual grass and weeds on the levee slopes and easements.					
Inspector Comment					
Annual vegetation is well maintained, Spring 2018.

View looking upstream landside of the well maintained vegetation.

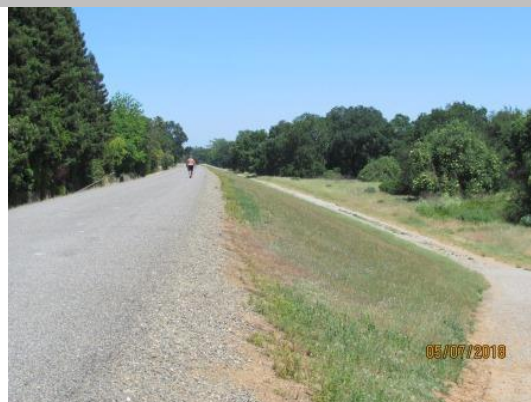
Photo 1 of 1 : SP_2018_NA0001_60_19_20180515_00047.jpg

LM Start	0.03	Rating **	A	Issue No.	19
LM End	4.19	Issue Type +	Ma	Location *	WS
Category	Earthen Levee			GPS Latitude/Longitude	
				Start	End
Item	Vegetation			38.567978 °	38.588967 °
				-121.383752 °	-121.428257 °
DWR ID	DWR_NA0001_09_s_2018_19				
Comment Code					
V1 : Control annual grass and weeds on the levee slopes and easements.					
Inspector Comment					
Annual vegetation is well maintained, Spring 2018.

View looking upstream waterside of the well maintained vegetation.

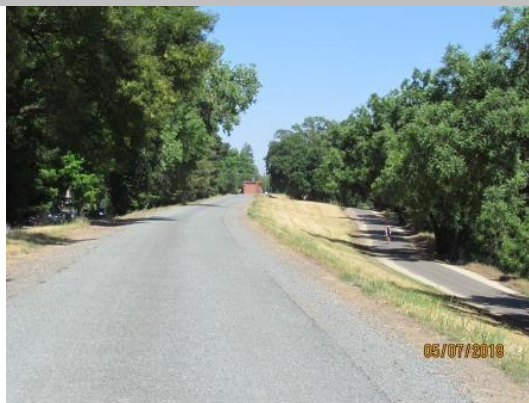
Photo 1 of 1 : SP_2018_NA0001_61_20_20180515_00046.jpg

LM Start	0.00	Rating **	A	Issue No.	20
LM End	3.87	Issue Type +	Ma	Location *	WS
Category	Earthen Levee			GPS Latitude/Longitude	
				Start	End
Item	Vegetation			38.600443 °	38.567771 °
				-121.330793 °	-121.382581 °
DWR ID	DWR_NA0001_10_s _ 2018_20				
Comment Code					
V1 : Control annual grass and weeds on the levee slopes and easements.					
Inspector Comment					
Annual vegetation is well maintained, Spring 2018.

View looking upstream waterside of the well maintained vegetation.

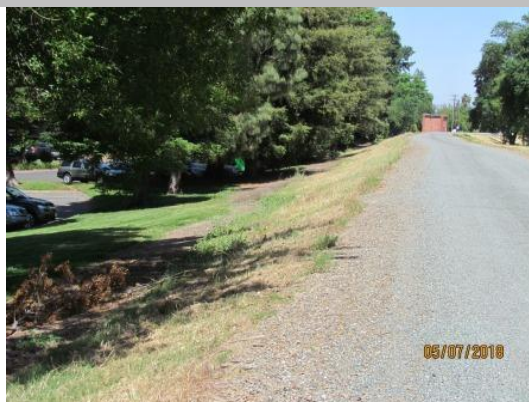
Photo 1 of 1 : SP_2018_NA0001_61_19_20180515_00047.jpg

LM Start	0.00	Rating **	A	Issue No.	19
LM End	3.87	Issue Type +	Ma	Location *	LS
Category	Earthen Levee			GPS Latitude/Longitude	
				Start	End
Item	Vegetation			38.600443 °	38.567771 °
				-121.330793 °	-121.382582 °
DWR ID	DWR_NA0001_10_s _ 2018_19				
Comment Code					
V1 : Control annual grass and weeds on the levee slopes and easements.					
Inspector Comment					
Annual vegetation is well maintained, Spring 2018.

View looking upstream landside of the well maintained vegetation.

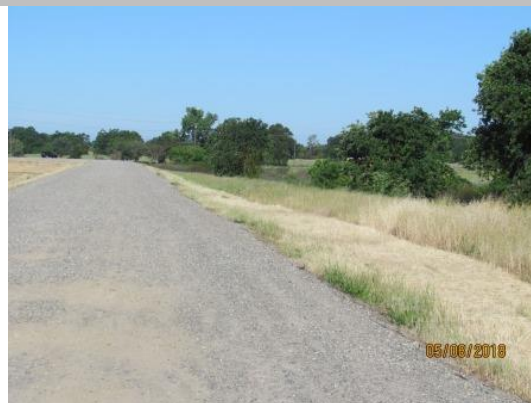
Photo 1 of 1 : SP_2018_NA0001_436_6_20180515_00009.jpg

LM Start	0.01	Rating **	A	Issue No.	6
LM End	0.72	Issue Type +	Ma	Location *	WS
Category	Earthen Levee			GPS Latitude/Longitude	
				Start	End
Item	Vegetation			38.662486°	38.667934°
				-121.457729°	-121.447566°
DWR ID	DWR_NA0001_11_s_2018_6				
Comment Code					
V1 : Control annual grass and weeds on the levee slopes and easements.					
Inspector Comment					
Annual vegetation is well maintained, Spring 2018.

View looking downstream waterside of the well maintained vegetation.

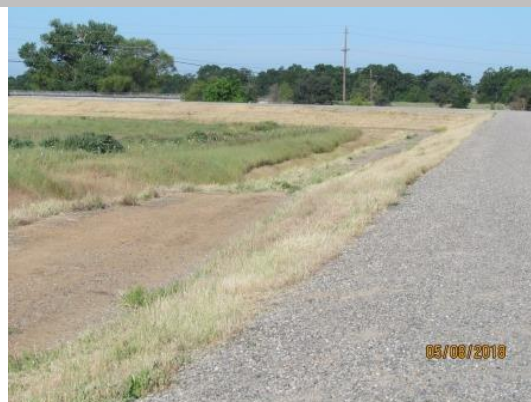
Photo 1 of 1 : SP_2018_NA0001_436_5_20180515_00010.jpg

LM Start	0.01	Rating **	A	Issue No.	5
LM End	0.72	Issue Type +	Ma	Location *	LS
Category	Earthen Levee			GPS Latitude/Longitude	
				Start	End
Item	Vegetation			38.662487 °	38.667933 °
				-121.457729 °	-121.447566 °
DWR ID	DWR_NA0001_11_s_2018_5				
Comment Code					
V1 : Control annual grass and weeds on the levee slopes and easements.					
Inspector Comment					
Annual vegetation is well maintained, Spring 2018.

View looking downstream landside of the well maintained vegetation.

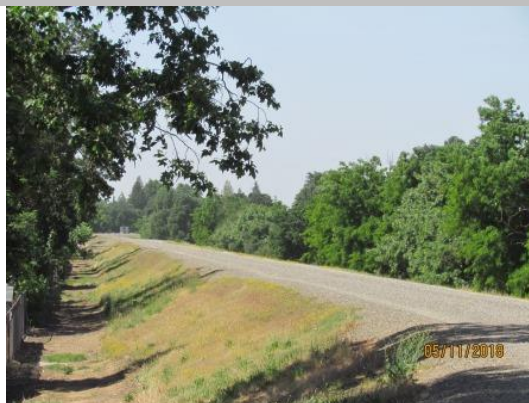
Photo 1 of 1 : SP_2018_NA0001_438_9_20180511_00016.jpg

LM Start	0.00	Rating **	A	Issue No.	9
LM End	0.83	Issue Type +	Ma	Location *	LS
Category	Earthen Levee			GPS Latitude/Longitude	
				Start	End
Item	Vegetation			38.570027 °	38.577244 °
				-121.353166 °	-121.342287 °
DWR ID	DWR_NA0001_12_s_2018_9				
Comment Code					
V1 : Control annual grass and weeds on the levee slopes and easements.					
Inspector Comment					
The annual vegetation is well maintained, Spring 2018.

View looking downstream on the landside of the well-maintained annual vegetation.

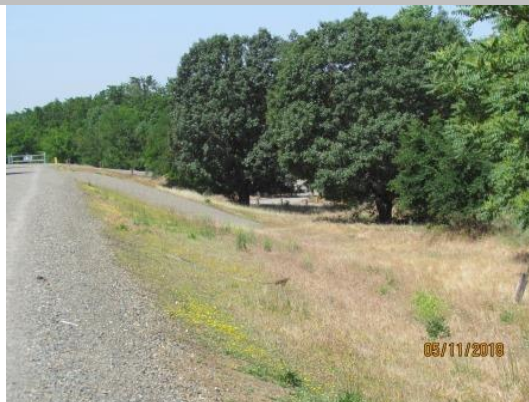
Photo 1 of 1 : SP_2018_NA0001_438_10_20180511_00015.jpg

LM Start	0.00	Rating **	A	Issue No.	10
LM End	0.83	Issue Type +	Ma	Location *	WS
Category	Earthen Levee			GPS Latitude/Longitude	
				Start	End
Item	Vegetation			38.570030 °	38.577249 °
				-121.353161 °	-121.342282 °
DWR ID	DWR_NA0001_12_s_2018_10				
Comment Code					
V1 : Control annual grass and weeds on the levee slopes and easements.					
Inspector Comment					
The annual vegetation is well maintained, Spring 2018.

View looking downstream waterside of the well-maintained vegetation.
